Manhole Inspection Summary

Manhole # S37GG1005MH

Location Address: **3919 GREENMOUNT AVE**

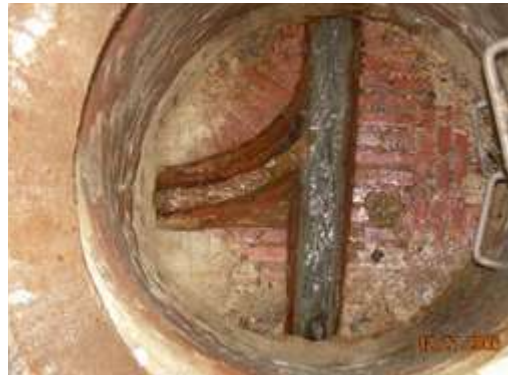
Top View

Evidence of surcharge - Bench debris.

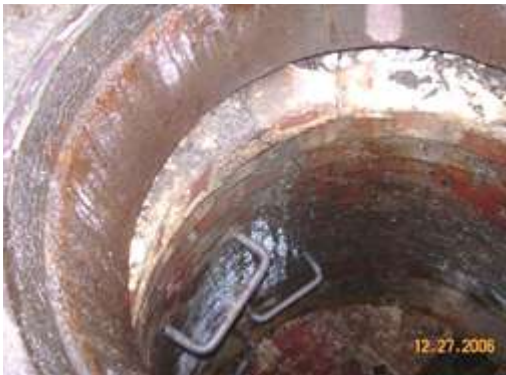
Defect

Frame leaks. Frame offset. Adjustment deterioration and infiltration. Corbel and Barrel infiltration.

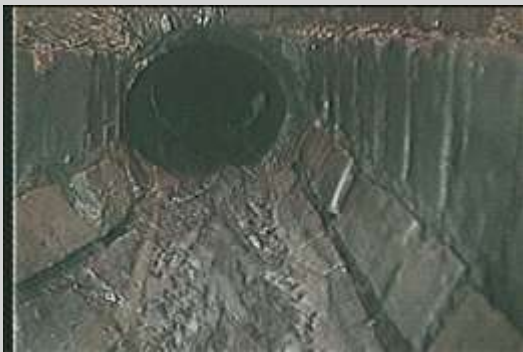
8 in. Circular Gravity Sewer Pipe Out @ 12 O'Clock

Channel deterioration.

Infiltration: **Evidence** Pipe Seal Cond: **Unknown**

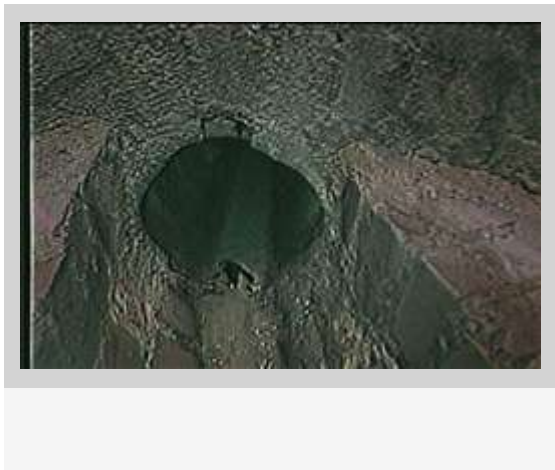
8 in. Circular Gravity Sewer
Pipe In @ 9 O'Clock

Infiltration: **Evidence** Pipe Seal Cond: **Cracked**
